Fatigue response of pretensioned concrete beams

Thesis

The University of Texas at Austin

August 2003

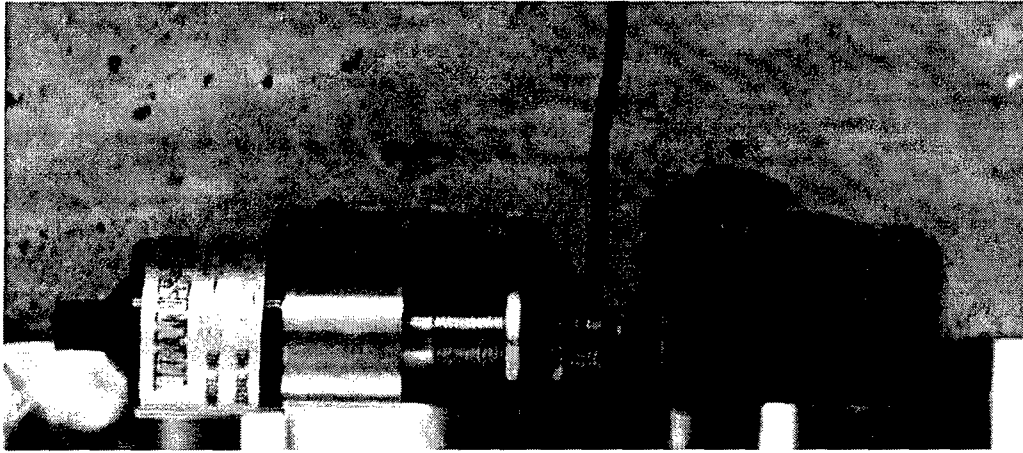
Once a crack formed, two more strain gages were attached to the bottom surface of the concrete, and a fourth LVDT was placed across the crack. The strain gages were 60-mm gages attached along the longitudinal axis of the beam on either side of the crack. The LVDT was attached using two short pieces of $L1\frac{1}{2} \times 1\frac{1}{2} \times \frac{1}{8}$ angles on the side of the beam approximately at the same height as the bottom of the beam as shown in Figure 3-5. This LVDT was a TRANS-TEK Model 0350-0000. Since the steel angles are separated by about $\frac{1}{2}$ in., the LVDT indicates both the crack width and the elastic deformation of the $\frac{1}{2}$ in. of concrete. The purpose of the LVDT was not to measure the crack width, rather to indicate when the crack opens. The surface strain gages were used for the same purpose.

Figure 3-5 LVDT Across Crack (Crack Displacement Gage)

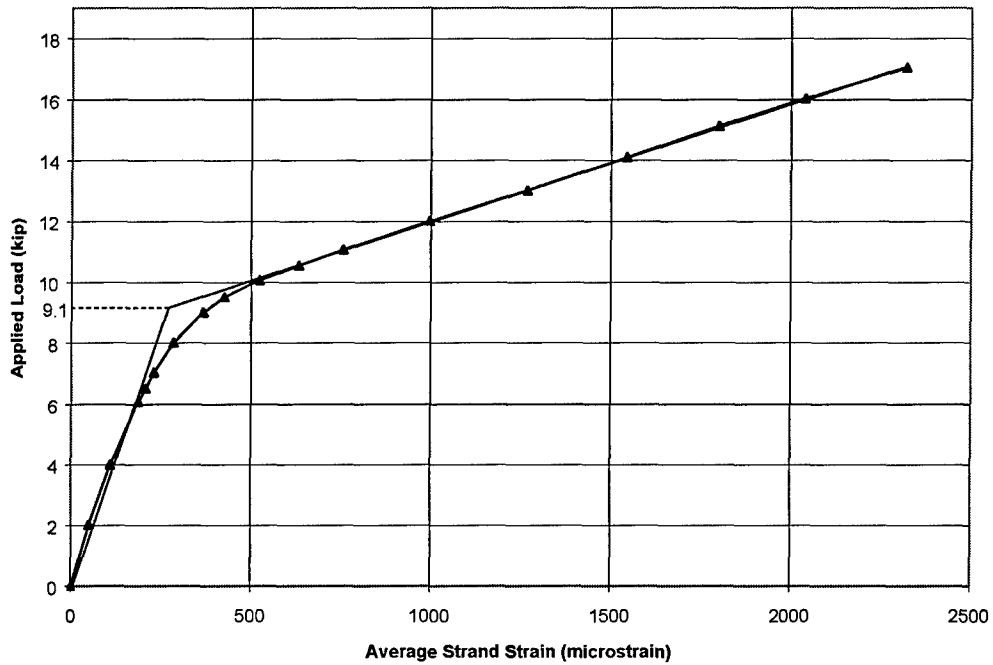
The decompression load is the applied load at which the bottom fiber concrete transitions from compression due to the prestress to tension due to flexure. The calculated decompression load for Beam 4 was 8.7 kip. The decompression load can be estimated from the measured response using the strand strain (Fig. 4-2), midspan deflection (Fig. 4-3), and crack gage displacement (Fig. 4-4). As can be seen in these figures, changes in stiffness in the vicinity of the decompression load are easily identified, but determining a unique value is not possible. For the purposes of this project, lines were fit to the measured data above and below the decompression load. The decompression load was then assumed to be the point at which the two lines intersected. Data from the third static test were used for this analysis. The results from this test were representative of all subsequent static tests conducted before the wires began to fail in fatigue.

**Figure 4-2 Estimated Decompression Load Using Average Strand Strain—
Beam 4**

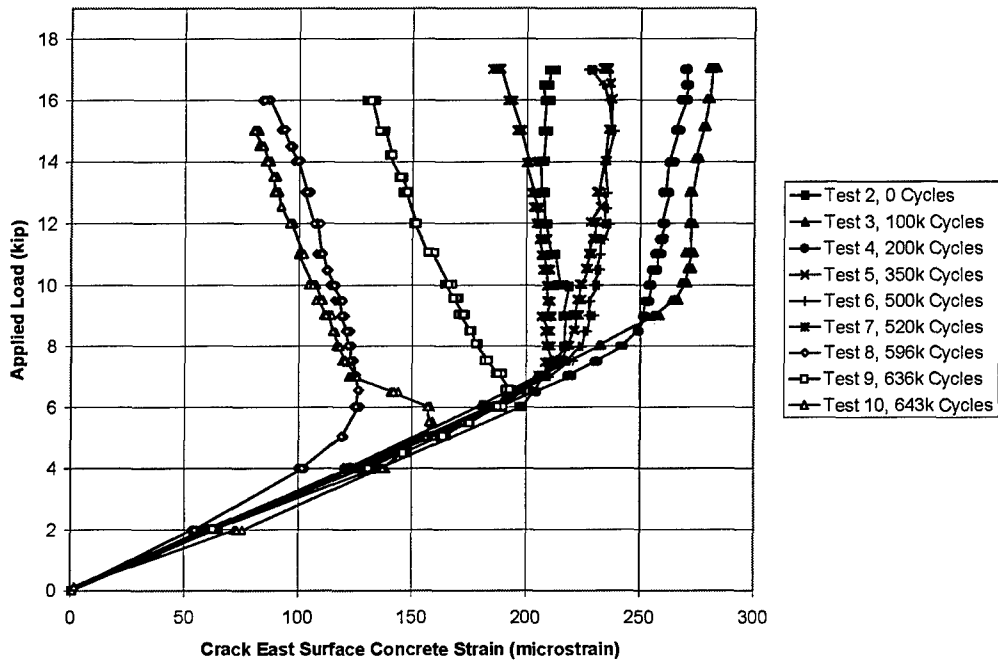
Figure 4-10 *Variation of Concrete Surface Strain East of Crack During Fatigue Tests—Beam 4*

Figures 4-10 and 4-11 are plots of the applied load vs. the concrete surface strain gage readings on either side of the prominent crack. All diagrams and photographs of beam crack patterns shown in this chapter show the south side of the beam (a north facing view), thus the east surface concrete gage was on the right of the prominent crack in these figures and the west surface concrete gage was on the left.

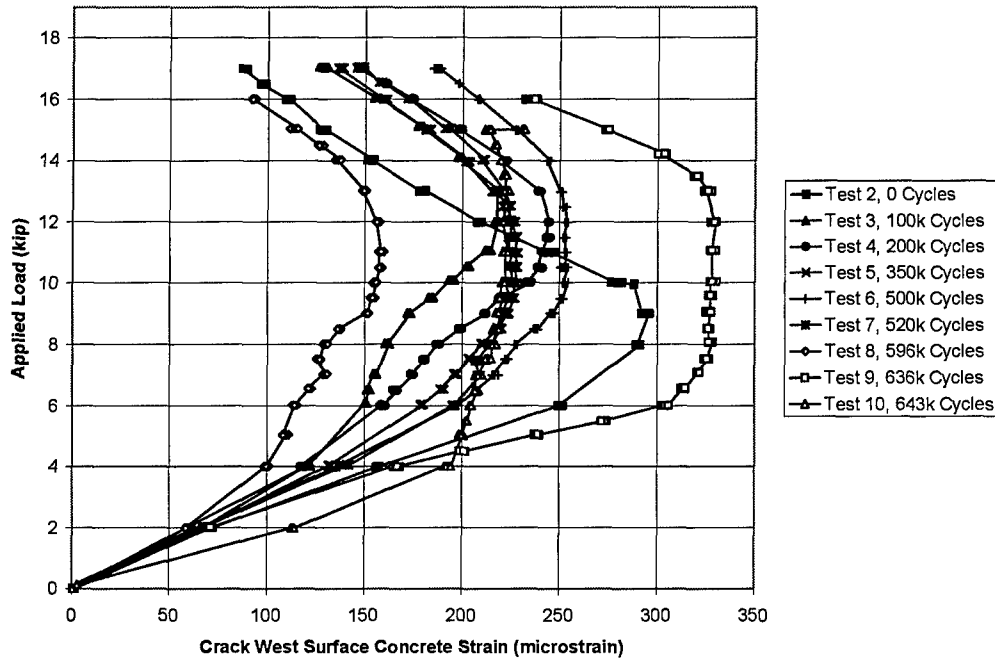
Figure 4-11 *Variation of Concrete Surface Strain West of Crack During Fatigue Tests—Beam 4*
